Building Number: 15

Original Name: Bowling Alley

Est. Year of Construction: 1961

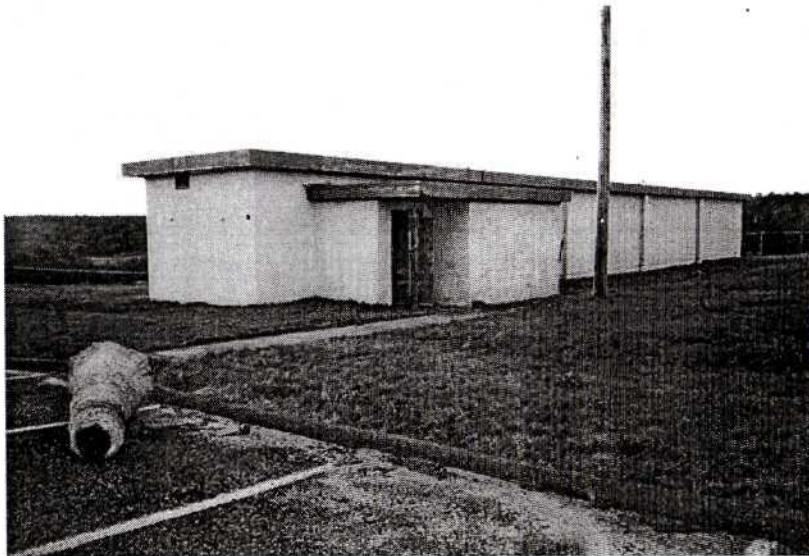
View from southeast.

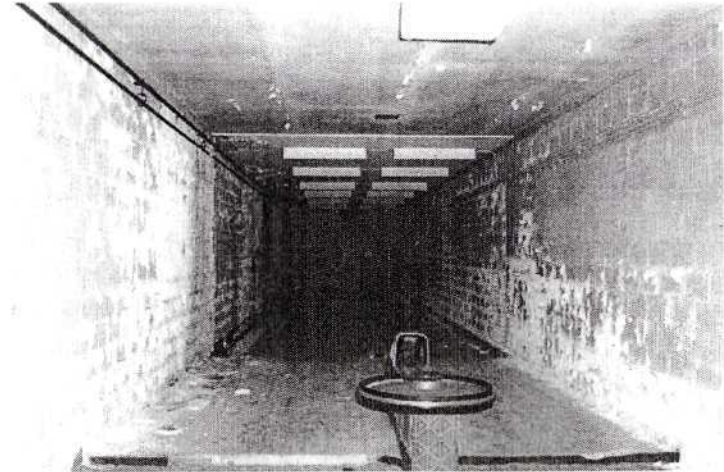
Interior, looking north.

- **Ceiling**
Interior ceiling is in **poor condition**. Leak in roof has damaged interior paint finish and acoustic ceiling tile (ACT).
- **Wall**
Painted interior finish is in **fair/poor condition**. Paint is peeling due to water damage from roof leaks. Advise refinishing of all interior CMU surfaces. Wood paneling in bathrooms is in **fair/good condition**.
- **Trim**
All baseboard, door, and fascia trim is in **fair condition**. Advise that all pieces be refinished and replace missing baseboard.
- **Floor**
Floor covering includes vinyl-asbestos tile (VAT) in the three ancillary spaces. Carpet covers the main space in front of the two wood lanes. Both finishes are in **fair condition**, but replacement is recommended. Concrete slab is missing (12") and raw-edged along the south wall and needs to be infilled and repaired.

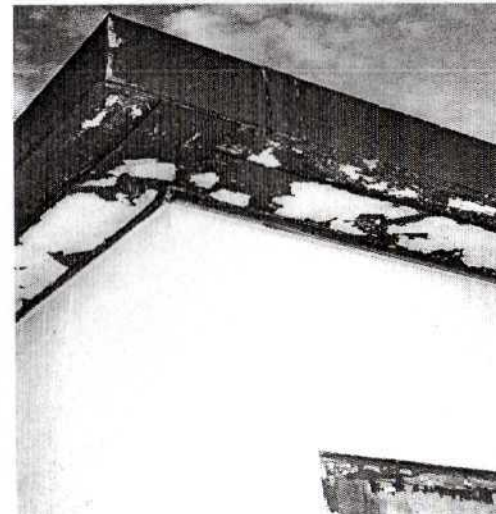
Detail of soffit at northeast corner.

- **Roof**
Flat roof is in **poor condition**. Soffits may be rotted; advise replacement of all soffit panels.
- **Wall**
Exterior is constructed of painted concrete masonry units (CMU). **Condition is fair**, but needs repointing. Some racking cracks. Advise 150 SF to be repaired and waterproofing throughout.
- **Trim**
Wide metal fascia trim is in **good condition**. Wood at low entry pavilion in **fair condition**. Recommend replacement of 20 LF of wood trim and repair soffit.
- **Foundation**
The foundation of Building #15 is slab-on-grade in **good condition**.

1. Repair/replace framing and sheathing	150	sf
2. Remove and replace damaged soffits	340	lf
3. Install aluminum roof edge (cant, nailer, flashing)	340	lf

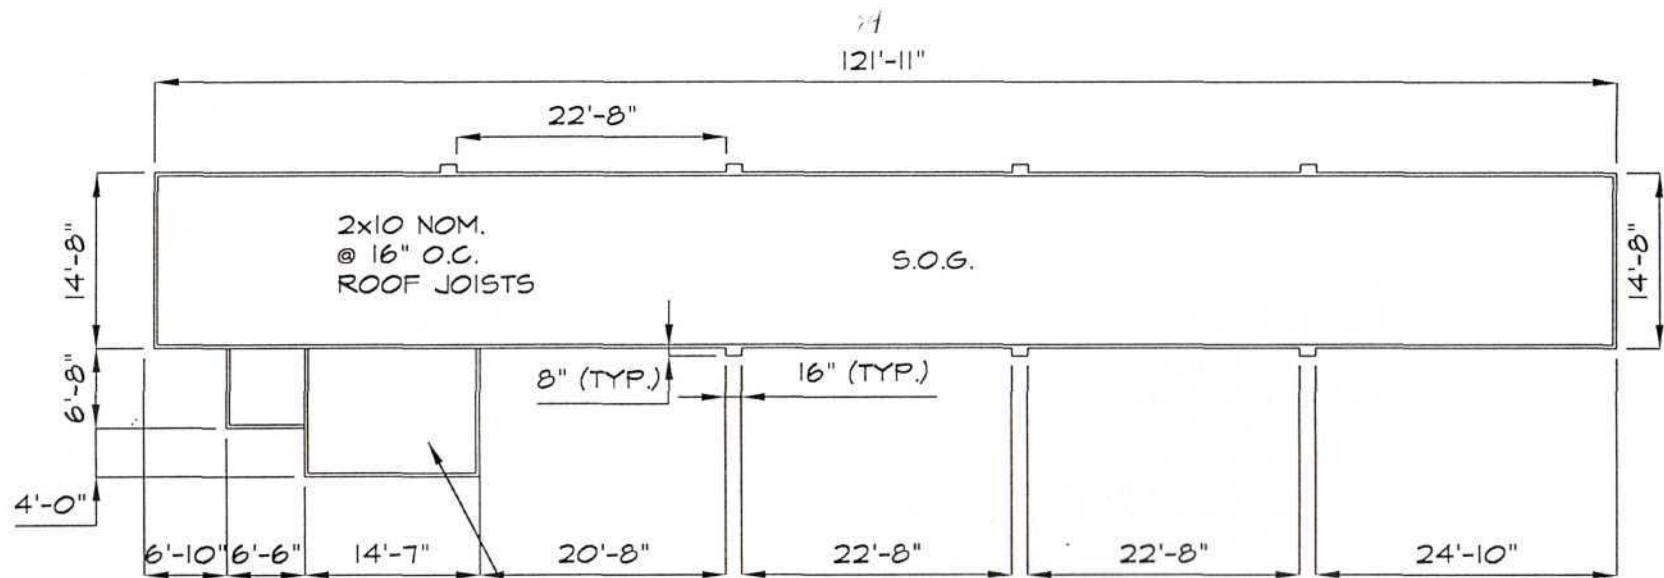
15

1. ALL WALLS ARE CMU
2. THE WALLS MUST BE WATERPROOFED AND THERE ARE SOME CRACKS THAT MUST BE REPOINTED.
3. FLAT ROOF

2x10 NOM.
@ 16" O.C.
ROOF JOISTS
